Dual-Band Infrared Computed Tomography: Searching for Hidden Defects

Dual-band infrared computed tomography systems developed at Lawrence Livermore are providing highly sensitive and accurate three-dimensional nondestructive inspection and evaluation of manmade structures in a variety of applications inside and outside the Laboratory.

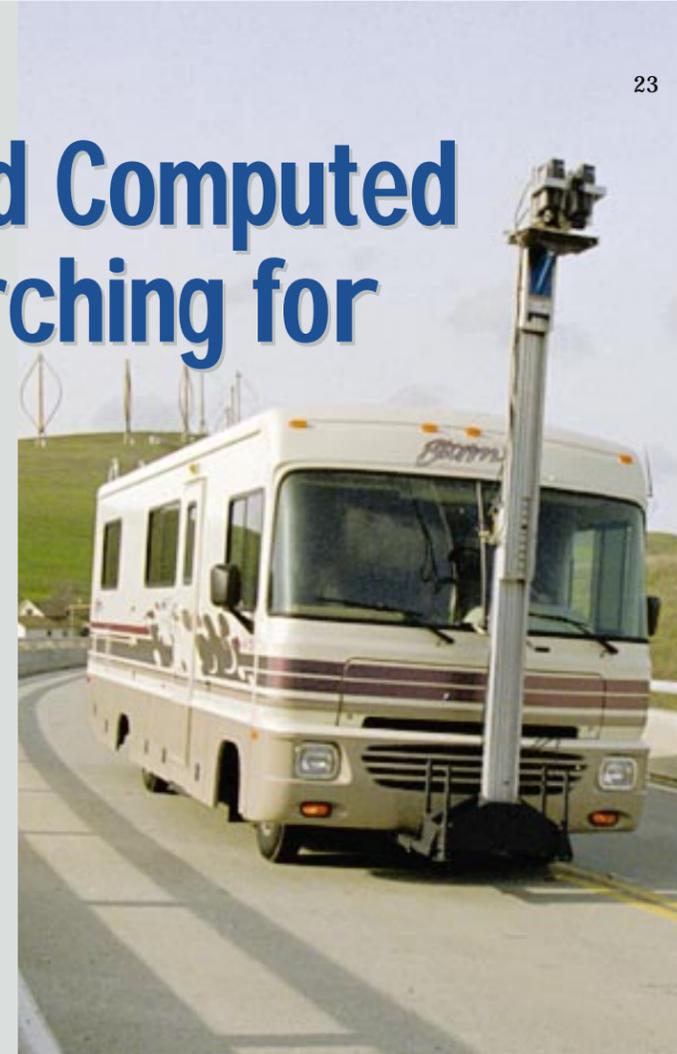
(Above) The dual-band infrared (DBIR) laboratory that the Federal Highway Administration is currently using for bridge inspection is a converted mobile home. The mobile DBIR laboratory's cameras, mounted about 4 meters (13 ft) above the roadway, scan the reinforced-concrete bridge deck for defects called delaminations. (Below) Delaminations are seen at the center of (a) the 8- to 12-micrometer (μm) longwave thermal infrared image and (b) the 3- to 5- μm shortwave image, both of which also show clutter. Clutter is identified in (c) the spectral difference map and later removed from (a) and (b) to create (d), which clearly shows only the delamination (minus clutter) as the bright yellow area with anomalous heat flow at the center of this image where temperatures are about 2°C warmer at noon and 0.4°C cooler at midnight.

With good results from the feasibility study, the Livermore team last year mounted DBIR cameras on a telescoping mast located at the front of a motor home that had been converted for field tests. The mobile DBIR Bridge Deck Laboratory successfully completed its first road test in November 1995 on the Grass Valley Creek Bridge near the Northern California town of Weaverville. Scientists were able to view 1-meter-long sections of roadbed approximately 1 meter (3 ft) long and one lane (3 meters or 10 ft) wide while traveling at 40 kilometers per hour (25 mph). VIEW computer codes developed at Livermore sped processing and analysis of the images, which had been recorded and stored on a high-speed hard disk.

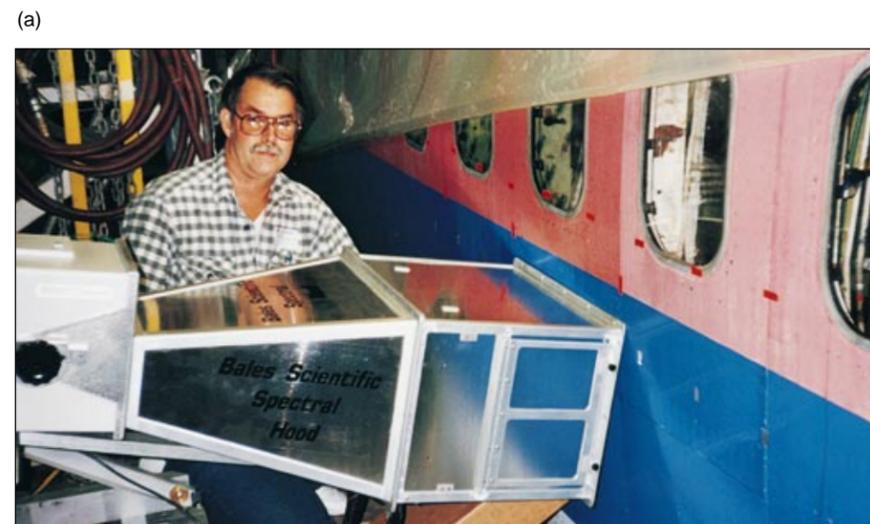
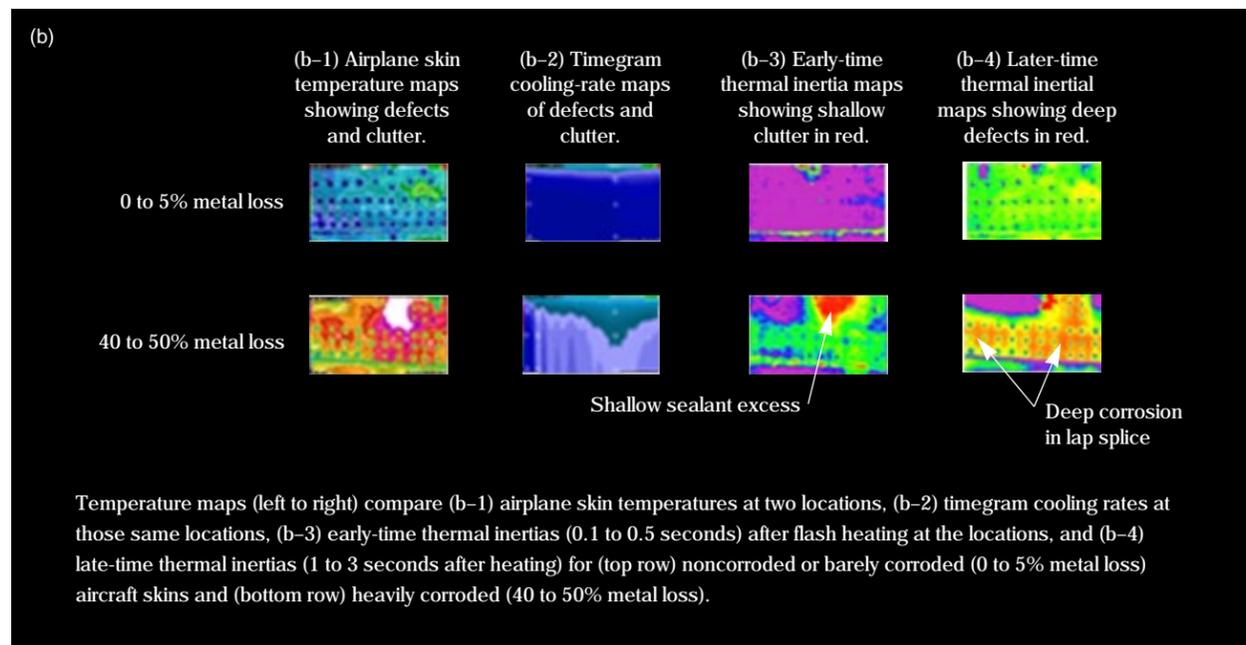
Figure 1. (a) Phil Durbin uses the DBIR system scanner, flashlamp, and spectral hood to look for metal loss from corrosion within the skin of an airplane. (b) What the DBIR system sees over time after flashlamp heating. Early- and late-time thermal inertia, temperature, and cooling-rate maps distinguish, through the power of computed tomography, subsurface clutter (shallow sealant excess) from deep corrosion (metal loss) in lapped metal splices.

Livermore's DBIR detection methods do not require aircraft disassembly. When applied to aircraft studies, DBIR can show the extent of metal corrosion near the aircraft skin's surface or deep within it. (Figure 1.) It can characterize the type of defects involved—such as gaps or areas with poor adhesive bonds with or without metal loss from corrosion. Also, it can differentiate between corrosion and conditions that may be mistaken for corrosion, such as fabrication ripples, surface roughness, and uneven sealant in a lap joint.

While the DBIR system for bridge inspections relies on natural heat sources, the system for aircraft inspections uses flashlamps and thus relies more on the computed tomography (CT) aspects of the technology than do DBIR bridge inspections. The metal skin is heated with uniform thermal pulses each lasting a few milliseconds. The resulting surface temperature changes, which vary with location and time, are then imaged by the dual-band scanner for analysis by computer. Hotter readings indicate areas of potential corrosion. A patent on the Laboratory's active (flash-heated) and passive (diurnally-heated) DBIR processes for imaging anomalous structural heat flows was issued in August 1995.
